Rigid Inclusions and Piles for Mixed-Use Redevelopment

DEEP FOUNDATIONS • MAR/APR 2021 • 79

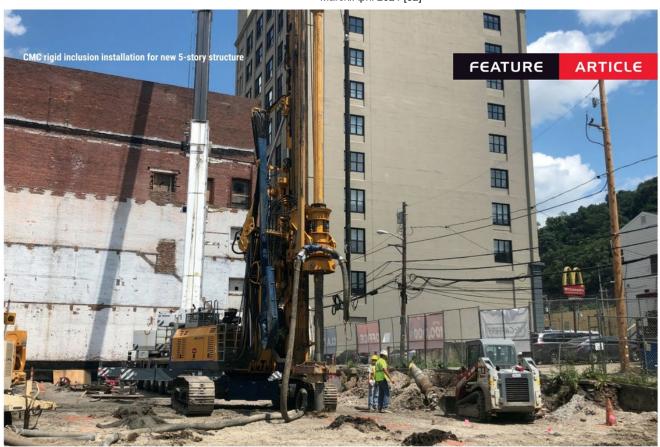
The plan for the site was to demolish existing 2- and 5-story buildings, leaving only the 4-story building standing. The façade of this adjacent 4-story building (back left of photo) remained, with the interior becoming new retail and office space. Two new stairwells and elevators shafts were added within the existing 4-story structure to service the new office spaces. A new 5-story structure on the southwest portion of the site would consist of ground-level retail space with a 4-story parking garage. The soils had a compressible nature at the site, so Menard recommended ground improvement using controlled modulus column (CMC) rigid inclusions to support the 5 stories. Due to the low overhead conditions within the existing 4-story structure, Menard recommended Magnum design the helical piles to support the new stairwells, elevator shafts and below-grade ramp into the garage.

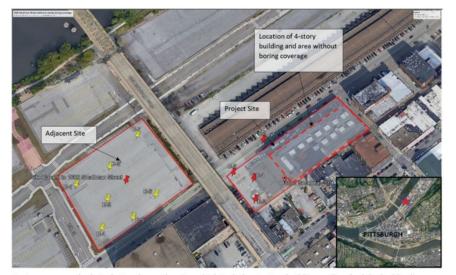
Boring coverage (red pins) at and near the site, which includes 4-story building outline (red dashed line) (credit: https://earth.google.com/)

Performing soil borings on site was a challenge because of existing structures. During the bid phase, borings located approximately 600 ft (182.8 m) away at an adjacent site were used to approximate soil properties (see later boring map). During final design, a geotechnical investigation was performed, but was limited to the parking lot area, as the 2- and 5-story buildings had yet to be demolished. The closer borings were used to refine the ground

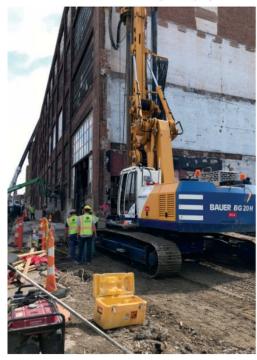
CMC installation near 4-story building façade
