Deep Foundations

Wick Drains Into the Unknown

This wick drain project took place in Long Beach, California, at the Long Beach Middle Harbor Redevelopment. For much of the past decade, the Port of Long Beach undertook a \$1.5 billion redevelopment of two outdated terminals to create the Long Beach Container Terminal (LBCT). To achieve this goal, the existing terminals were demolished and the slip that serviced one of the older terminals was designed to be infilled to create the new area that would allow for the LBCT to manage 3.3 million TEUs (a

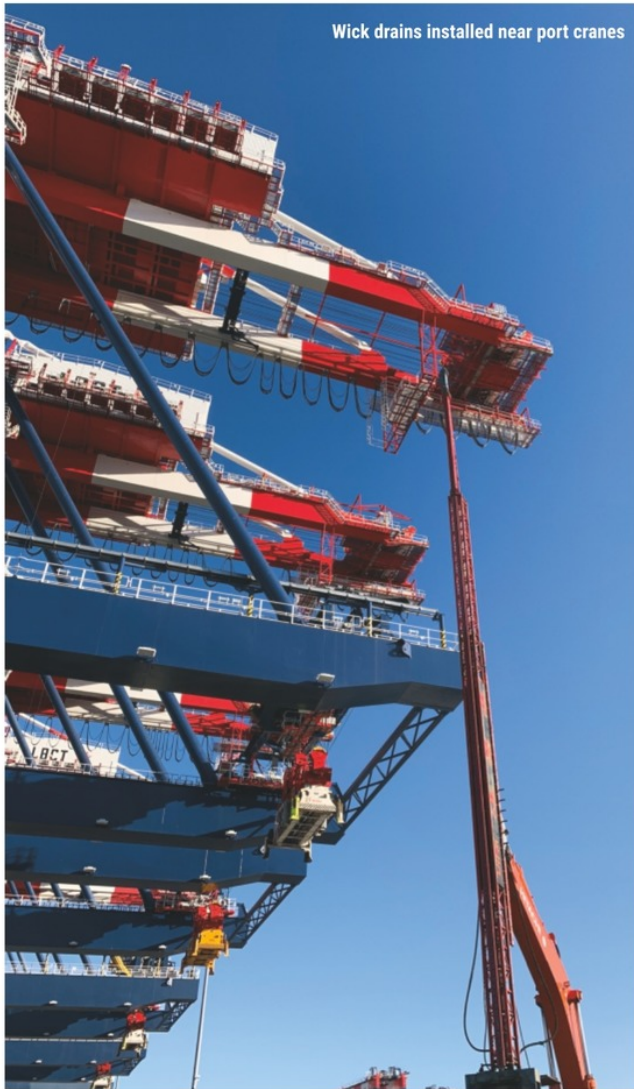
Wick drains installed near port cranes

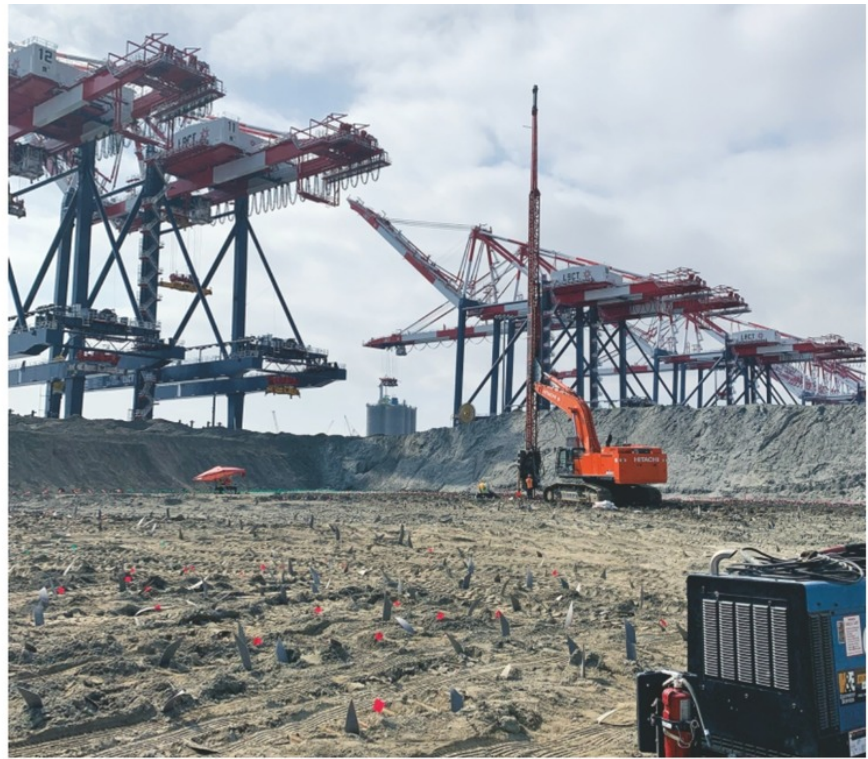
Finishing wick installation in pre-augered holes

The specifications presented additional risks beyond the typical geotechnical risks to installation quantity and schedule. Pre-augering, a supplemental activity that loosens the soil at the wick drain location using a continuous flight auger, was considered incidental to the wick drain installation. Based on previous experiences at the site, as well as from other port projects, it can be common for the fill material placed above the water line using mechanical means (i.e., dump trucks and bulldozers) to require pre-augering

to meet typical production rates. Another anticipated risk was the requirement to make up to two reattempts at wick drain installation if the drains hit an obstruction or a dense layer prior to the designed termination elevation. Ultimately, an installation plan was developed to attempt all wick drains without pre-augering, and, if needed, would return to an area with shallow obstructions/dense layers with a pre-auger and only make one installation attempt on pre-augered locations.

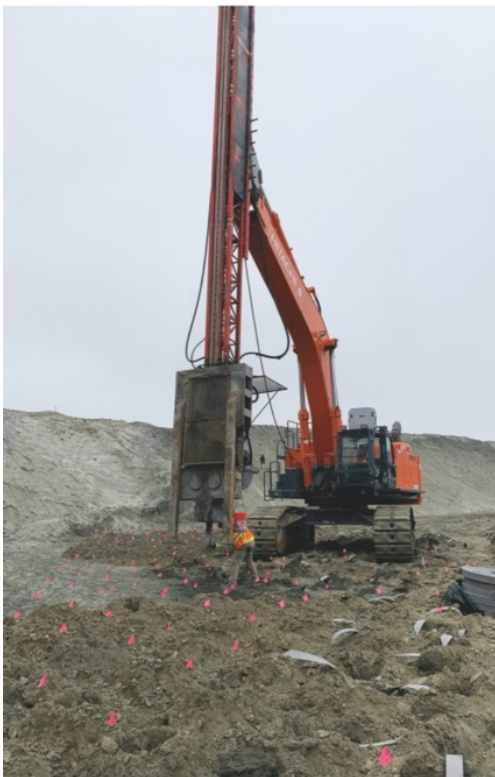
Installation with reattempted wicks in the foreground

Another anticipated risk was the requirement to make up to two reattempts at wick drain installation if the drains hit an obstruction or a dense layer prior to the designed termination elevation.

carried costs for pre-augering was expected, the actual refusals were occurring much deeper than could be economically addressed with pre-augering. At the start, refusal was defined as any drain that didn't get within 5 ft (1.5 m) of design tip elevation. To meet the letter of the specification, there were instances where two additional offset 65 ft (20 m) wick drains were installed within 18 in (450 mm) of the initial 65 ft (20 m) "refused" wick drain, with each trying to get to 76 ft (23 m).

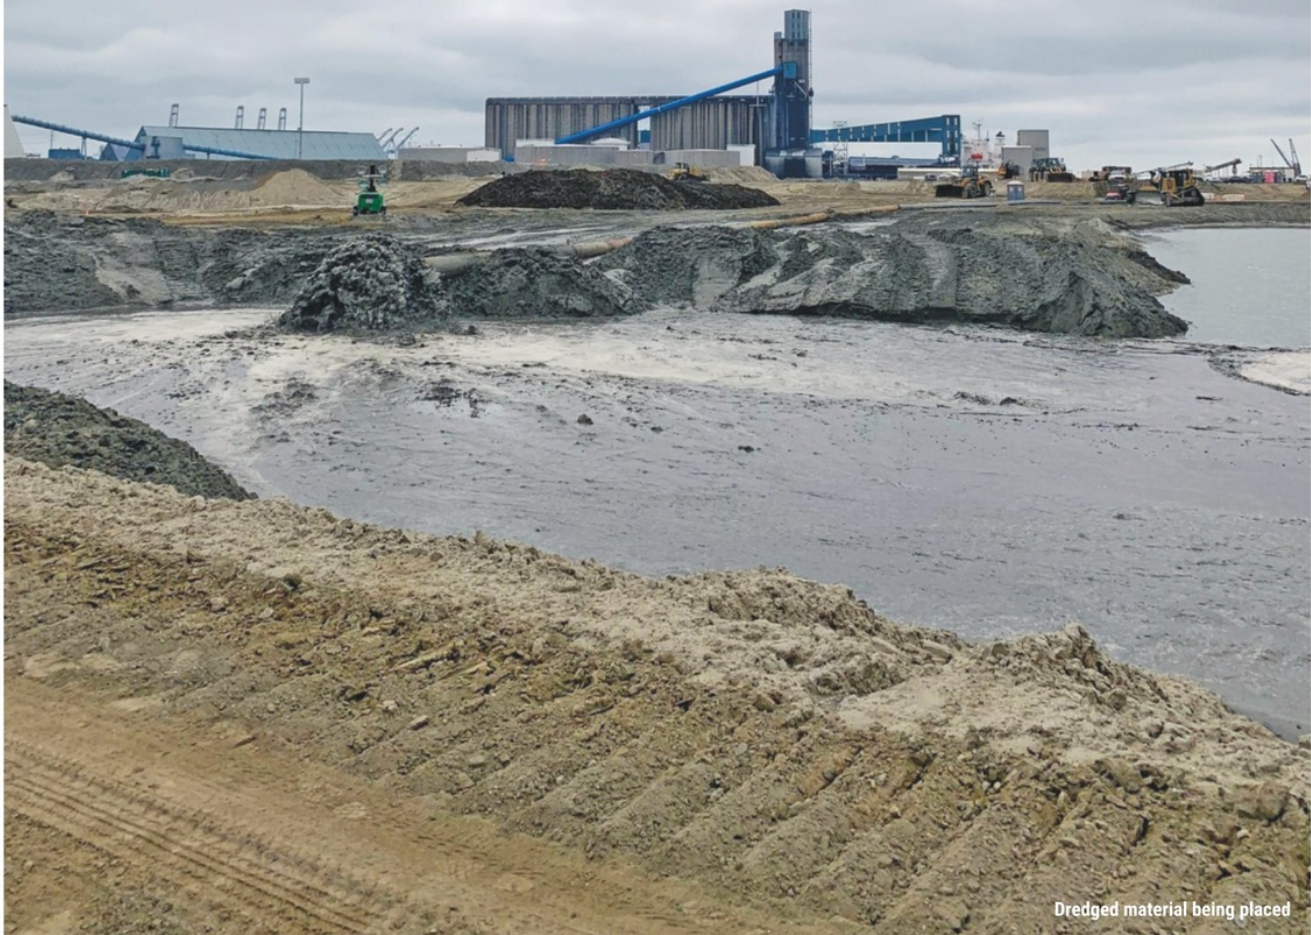
Dredged material being placed
