# Deep Foundations

JAN/FEB 2024

Support of Excavation for  
Microtunneling Shafts

# The Route 1&9T/New Road: An Outstanding Project Runner Up

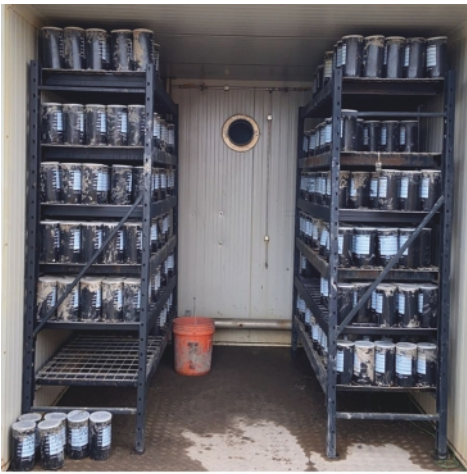
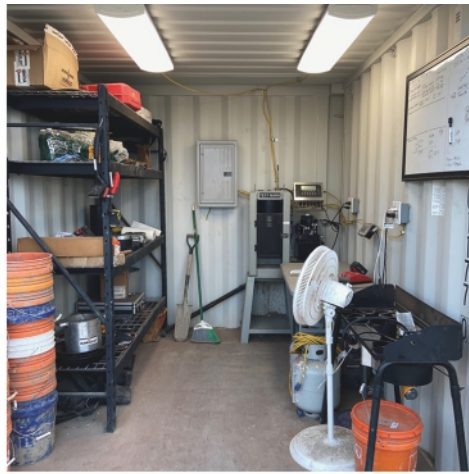
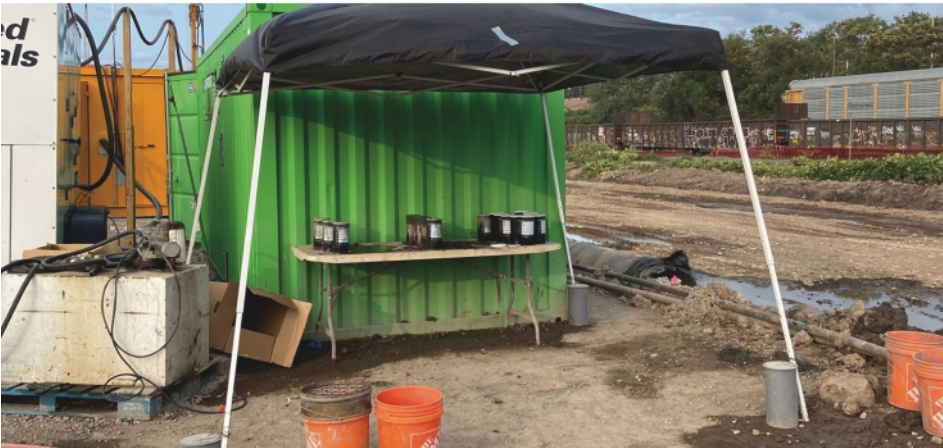
Testing lab

(FHWA) allows up to 10% of samples to fall below the target strength. Wet grab samples were taken with an excavator bucket every 75 cu yd (57 m<sup>3</sup>), which is at least three times the frequency recommended by the FHWA. Due to the large number of samples that would need to be collected, cured and tested, special-purpose modular on-site facilities were set up to allow for moisture content control, sample curing and strength testing.

Over nine months, the team collected more than 700 bulk samples, resulting in approximately 6,600 cylinders cast and tested. Of those samples, the median compressive strength after 28 days was 164 Psi (1.1 MPa) with a first quartile value of 110 Psi (0.75 MPa). Overall, 92% of the tested cells had a compressive strength above the initial 89 Psi (0.6 MPa) target value, meeting FHWA criteria. Cells that did not obtain this value were reanalyzed and often remixed. Of the 8% not meeting strength, remedial measures were taken to accommodate this by reducing the design's rigid inclusions spacing. Due to team (contractor and

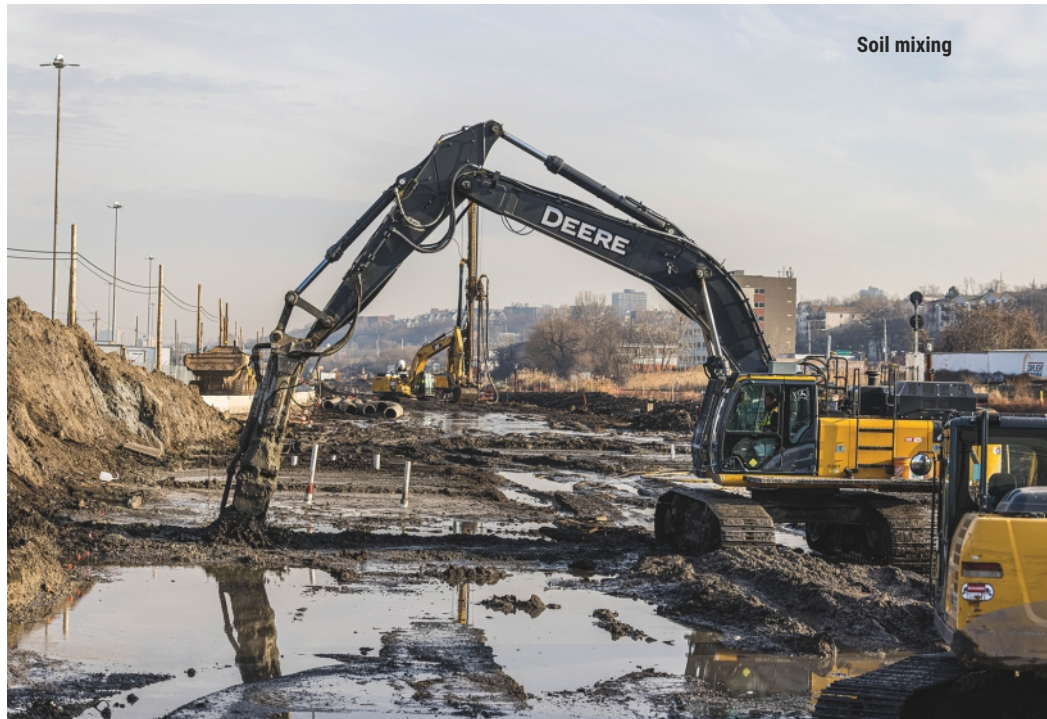
Soil mixing

Permit issues and the pandemic delayed the start of work by several months. This ultimately led to the soil mixing operation being completed in adverse winter conditions. Soil mixing field trials began in June 2020, followed by full production in July of 2020. The soil mixing operation faced a myriad of issues, which included restrictions and precautions due to the pandemic, pockets of higher than anticipated peat content, and higher than expected tidal water elevations. The latter required adding cement beyond the values obtained from the lab bench scale testing, additional rigid inclusions and remixing in many cases. For all the panels mixed, about 35% were remixed, essentially doubling the cement content when high organic contents were present.

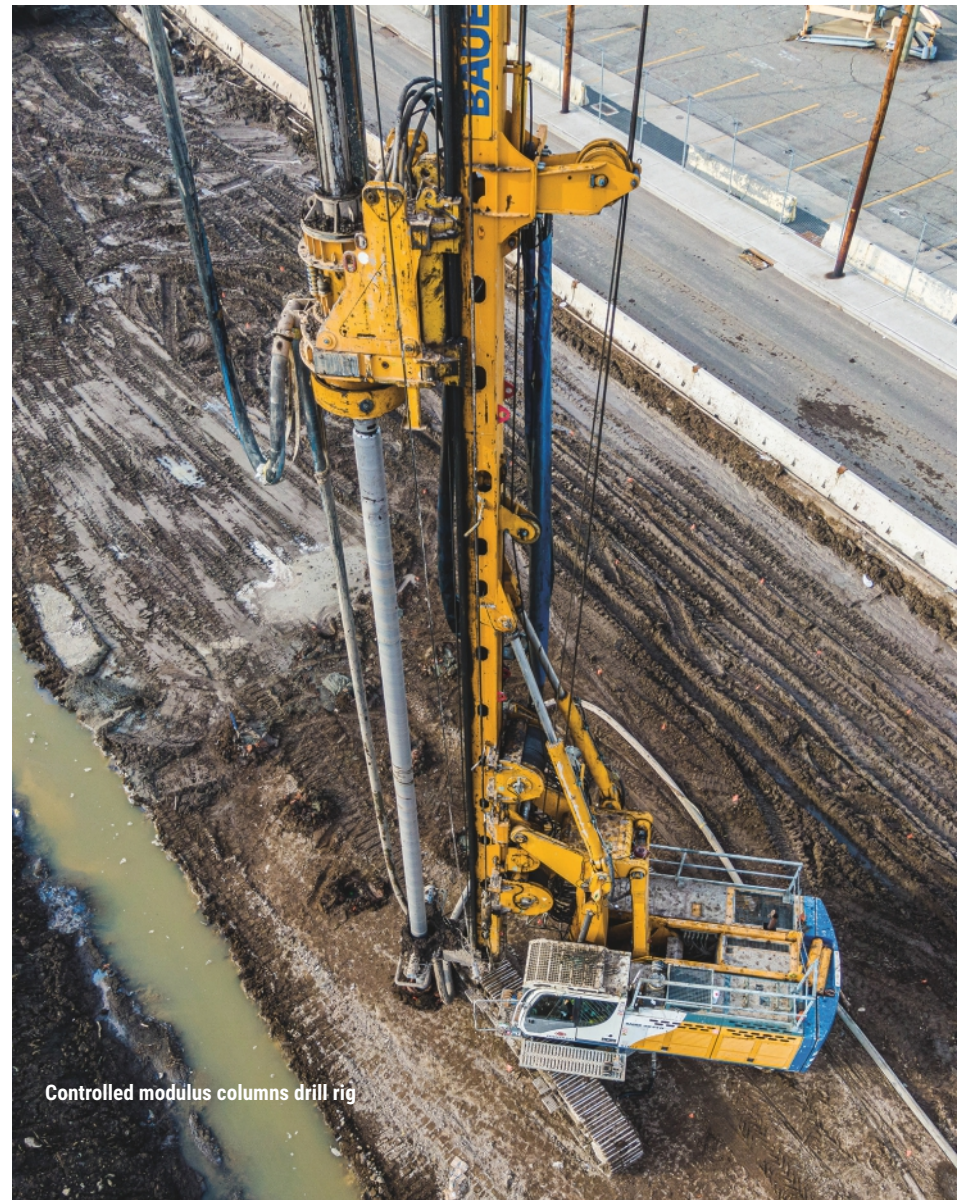
*The rigid inclusions were drilled through the shallow soil mix, organics, alluvium and lake bottom deposits before terminating mostly in the lacustrine fan deposits at depth.*

Controlled modulus columns drill rig

Following the soil mixing operation, rigid inclusion installation began in September 2020 and lasted until April 2021. Approximately 3,500 rigid inclusions were installed from atop the soil mixed LTP, or working platform surface in this instance, which varied in elevation based on the elevation of the bottom of the proposed retaining wall. The rigid inclusions were drilled through the shallow soil mix, organics, alluvium and lake bottom deposits before terminating mostly in the lacustrine fan deposits at depth. A computer-recorded log of the installation parameters was generated for each rigid inclusion and reviewed by on-site engineers. Occasionally if predetermined termination criteria were not achieved in the lacustrine fan deposits, indicating a slightly looser material, the rigid inclusions tipped into the glacial till layer.

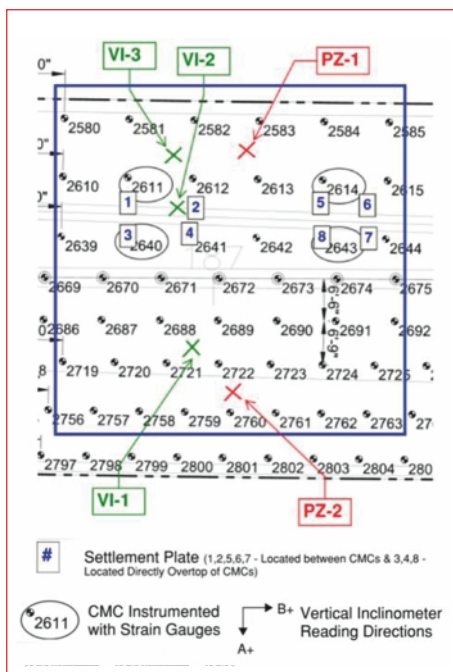
Area load test layout plan

In addition to the single-element static load tests, a fully instrumented area load test covering 43 rigid inclusions was also performed. The purpose of the area load test was to verify performance of the entire ground improvement system including the efficiency of load transfer through the interaction of the LTP with the rigid inclusion. Fill above the rigid inclusions was built up incrementally to a maximum height of twice the final fill height with hold periods at various levels to match the anticipated construction sequence across the rest of the roadway.

Deflection during the area load test was measured with eight settlement plates placed both between and directly above the rigid inclusions to observe differential settlement across the spacing. Four controlled modulus columns were instrumented with strain gauges, similar to the single-element tests, to measure load along the length of the rigid inclusions. Three vertical inclinometers were installed to measure

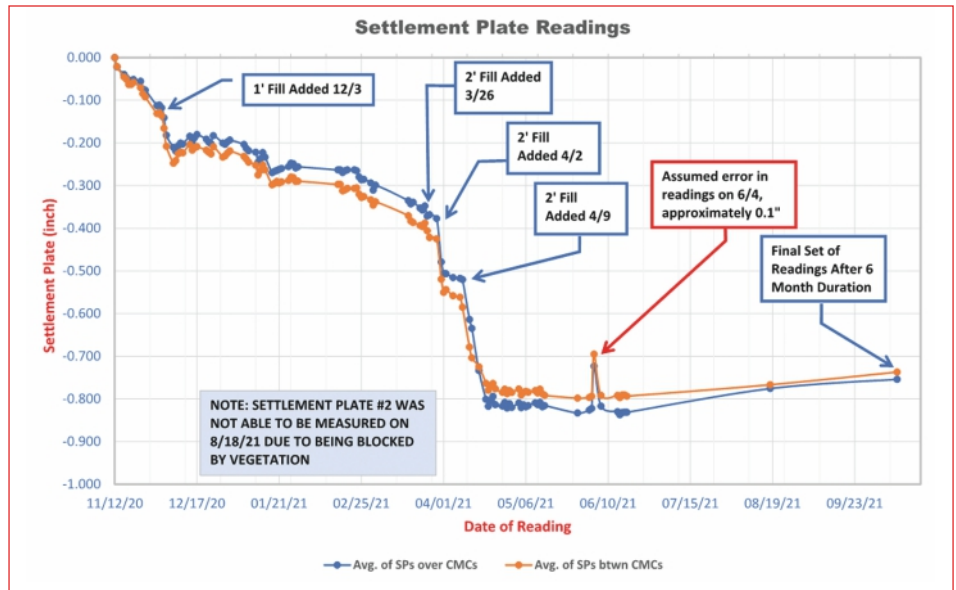
Additional fill and settlement plate readings after planned finished grade achieved

Under twice the final embankment height, the settlement plates showed total settlement between 0.6–0.9 in (15–23 mm) within the tested area, which met the project performance criteria of 1 in (25 mm) post-construction settlement. Additionally, the observed settlement above and between rigid inclusion locations was generally consistent, indicating that the LTP was performing uniformly. There was minimal fluctuation in pore pressure measured within the piezometers, which meant that the majority of the stress from the fill was entering the rigid inclusions and not the soil. Further, the strain gauge data confirmed the anticipated load curves within the rigid inclusions, with the maximum load being just below the bottom of the soil-mixed LTP. The inclinometer readings remained generally below 0.1 in (2.5 mm) for the duration of the area load test.
